Analysis of Tevatron 16 House Quench on December 5, 2003

D. Still, Fermi National Accelerator Laboratory*, Batavia, IL, 60510 USA

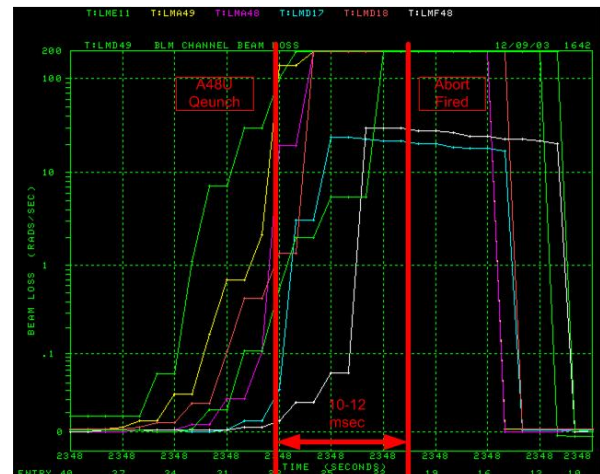
FIGURE 1. T44 loss buffer plot of losses at various locations during the 16 house quench.

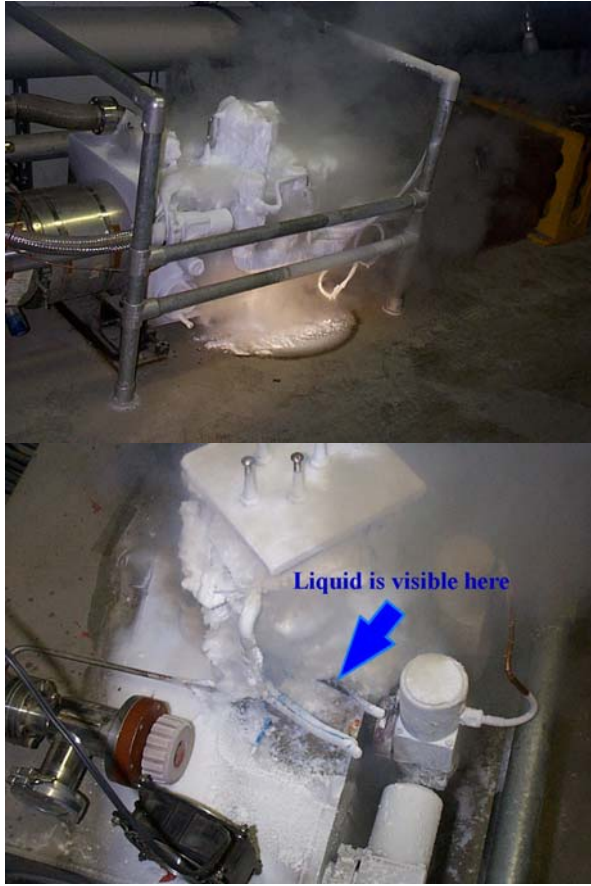
Damage to the C19 spool piece mainly involved a correction element feed through called the conning tower. This is where the warm correction element bus connects to the cold spool. The style that failed during the quench is of the “old” style and probably was already loose at the time of the quench. Large pressures induced by the quench resulted in 1 pin of 12 being pushed out of the conning tower. A couple of efforts to repair the pin while at 80K failed requiring the C1 house to be warmed up to room temperature to replace the conning tower.

FIGURE 8. Picture of a helium leak on the C19 spool conning tower. The #1 pin and later more pins are leaking helium. After many efforts to repair the conning tower it was decided to warm up the C1 house and replace the C19 spool.
